Manhole Inspection Summary

Manhole # S37II1013MH

Insp Date: **1/12/07 10:43 AM**

Location Address: **523 ROSE HILL TERR**

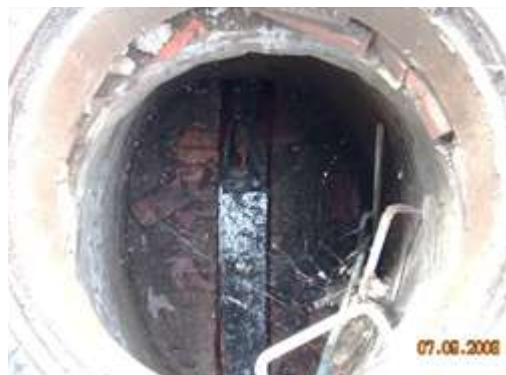
Top View

Corroded steps. Evidence of surcharge - Bench debris. Channel debris.

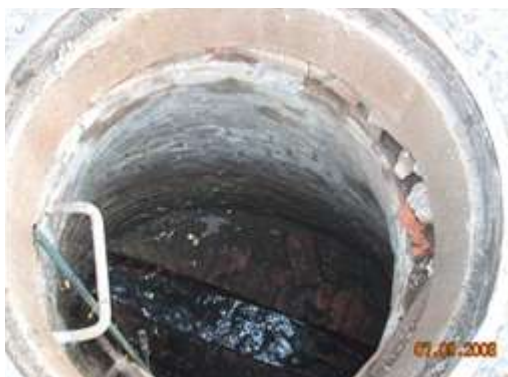
Defect

Frame leaks. Frame offset. Adjustment deterioration, loose brick, cracks and infiltration. Corbel and Barrel infiltration.

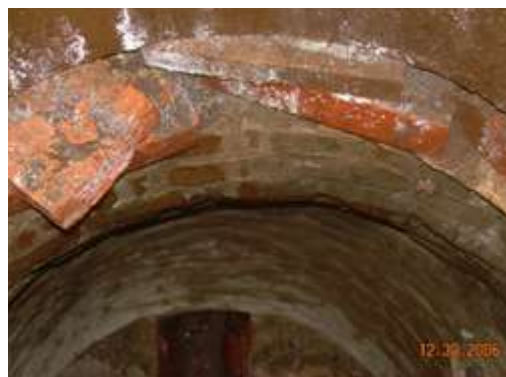
Defect

Frame leaks. Adjustment deterioration, loose brick and infiltration. Corbel and Barrel infiltration.

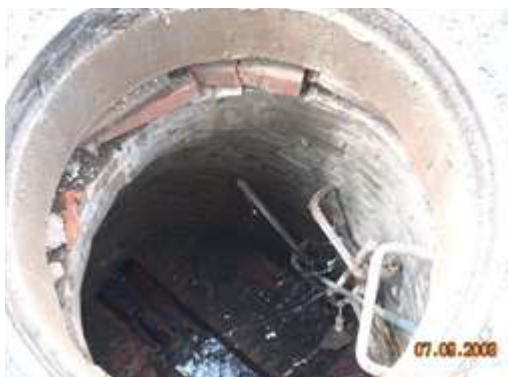
Defect

Frame leaks. Frame offset. Adjustment deterioration, loose brick, cracks and infiltration. Corbel and Barrel infiltration.

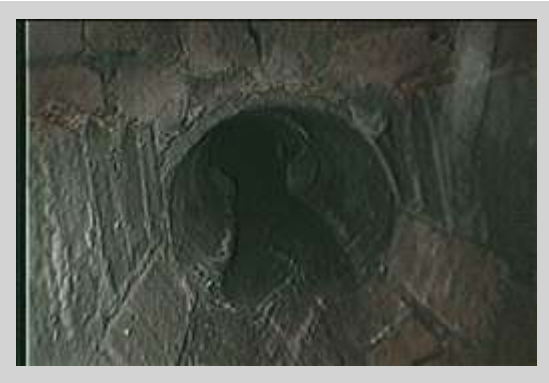
8 in. Circular Gravity Sewer Pipe Out @ 12 O'Clock

Barrel deterioration and infiltration. Channel deterioration.

Infiltration: **Evidence** Pipe Seal Cond: **Cracked**

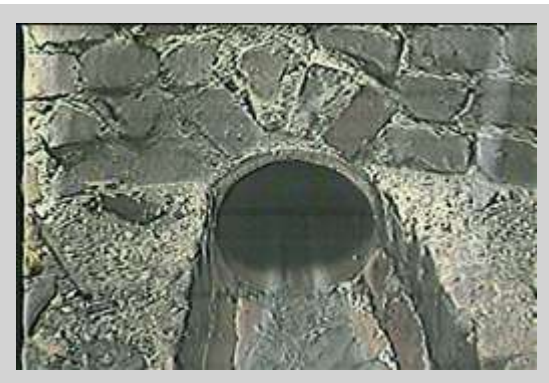
8 in. Circular Gravity Sewer Pipe In @ 6 O'Clock

Barrel deterioration and infiltration. Channel deterioration.
